**RE: Expired Warranty**

**RE: EVE UNIT 3707**

### Deficiency History Lot:3707 Eve - Phase: 1

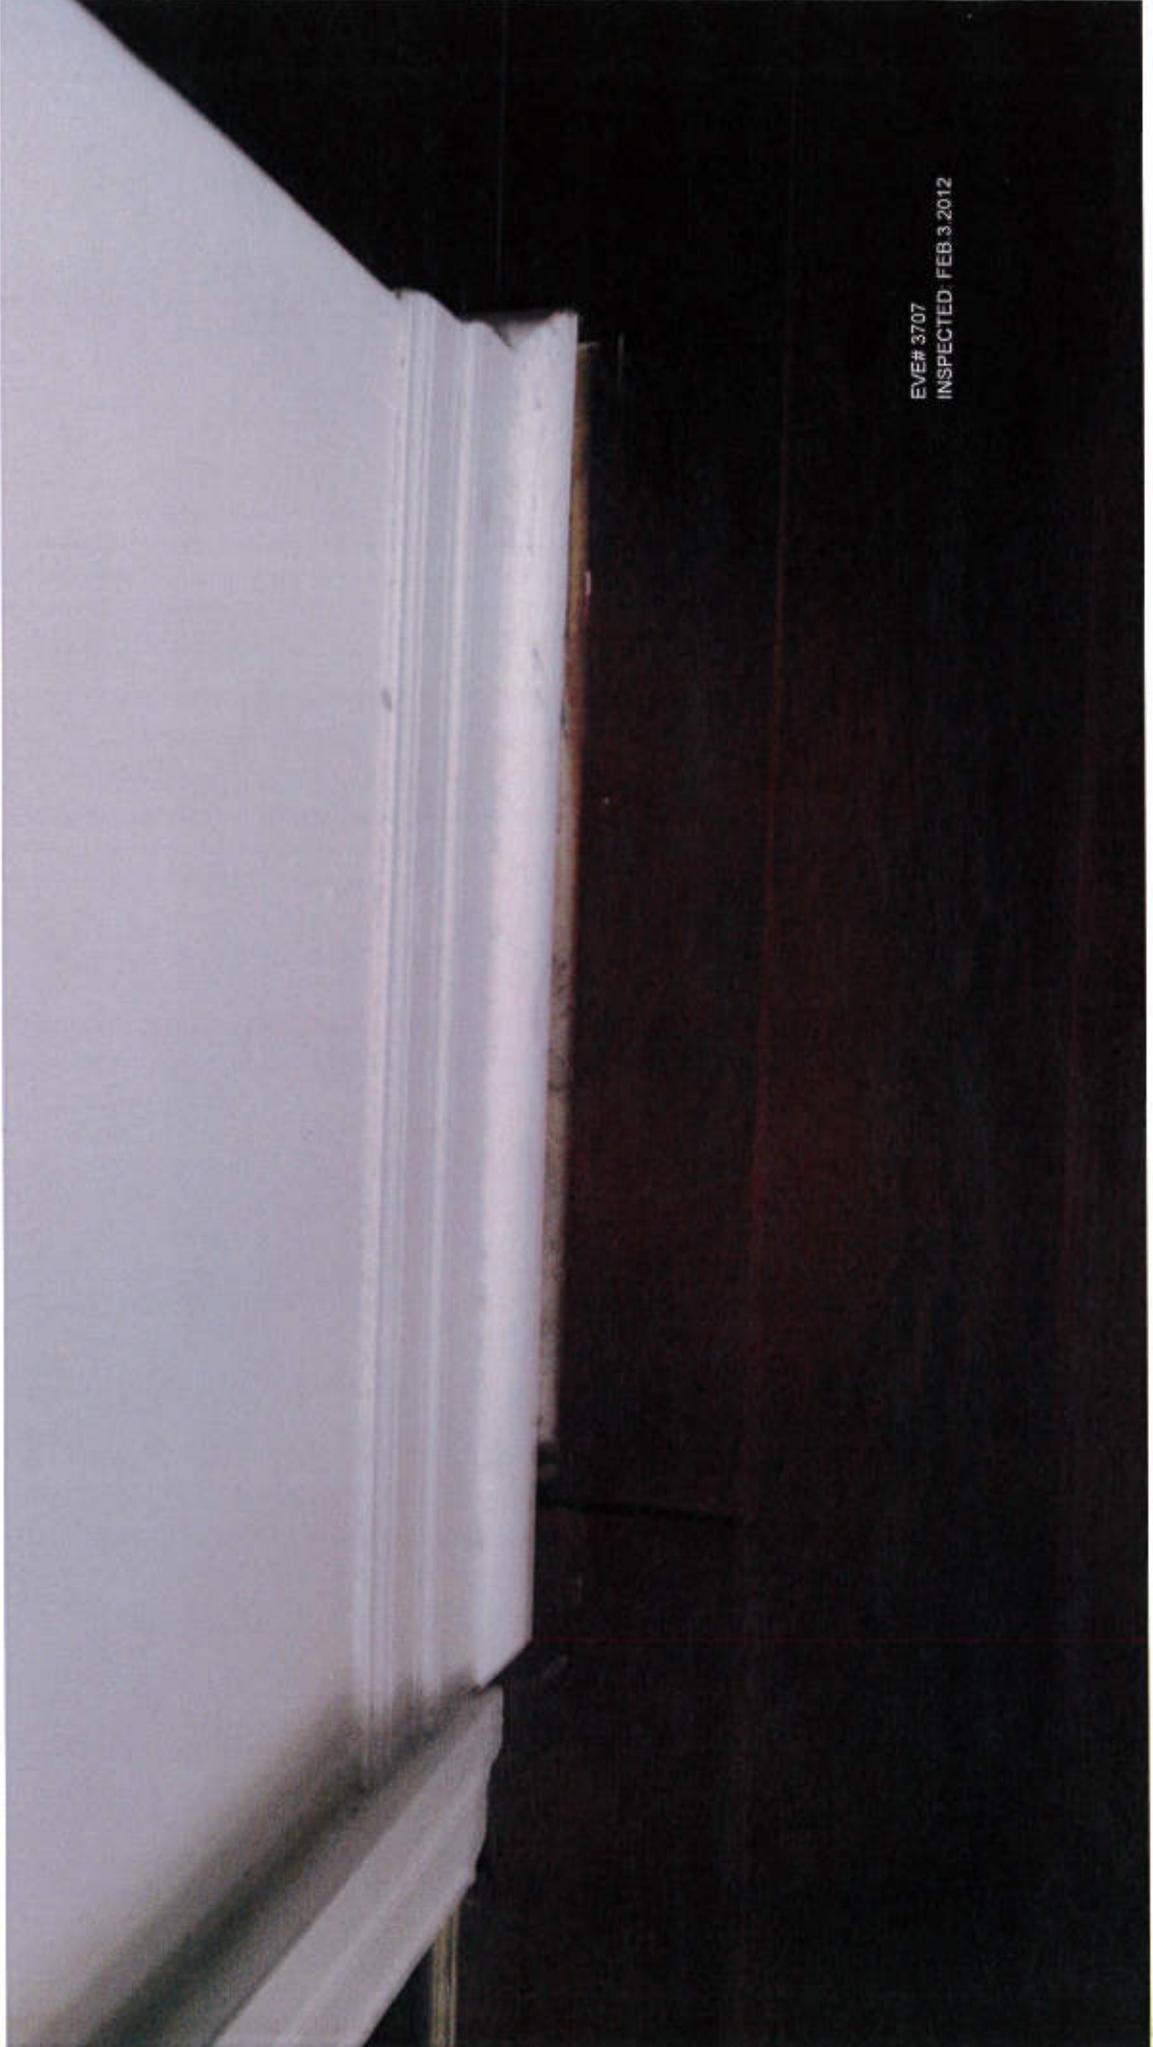
EVE# 3707  
INSPECTED: FEB.3.2012

As per my inspection of Suite 3707, I find it evident that there has been some form of water damage that has damaged the surface of the floor as well as a humidity issue that is drying out the floor causing it to shrink considerably.
