From: Jim Hill [jimh@allanwindows.com]
Sent: February-06-12 8:01 PM
To: Sandra Valencia; Grahme Walsh; Mark Fritz
Subject: Elle
Attachments: IMG00335-20120127-0925.jpg; IMG00331-20120127-0921.jpg;
IMG00332-20120127-0921.jpg; IMG00333-20120127-0922.jpg

Inspection Jan 27/2012

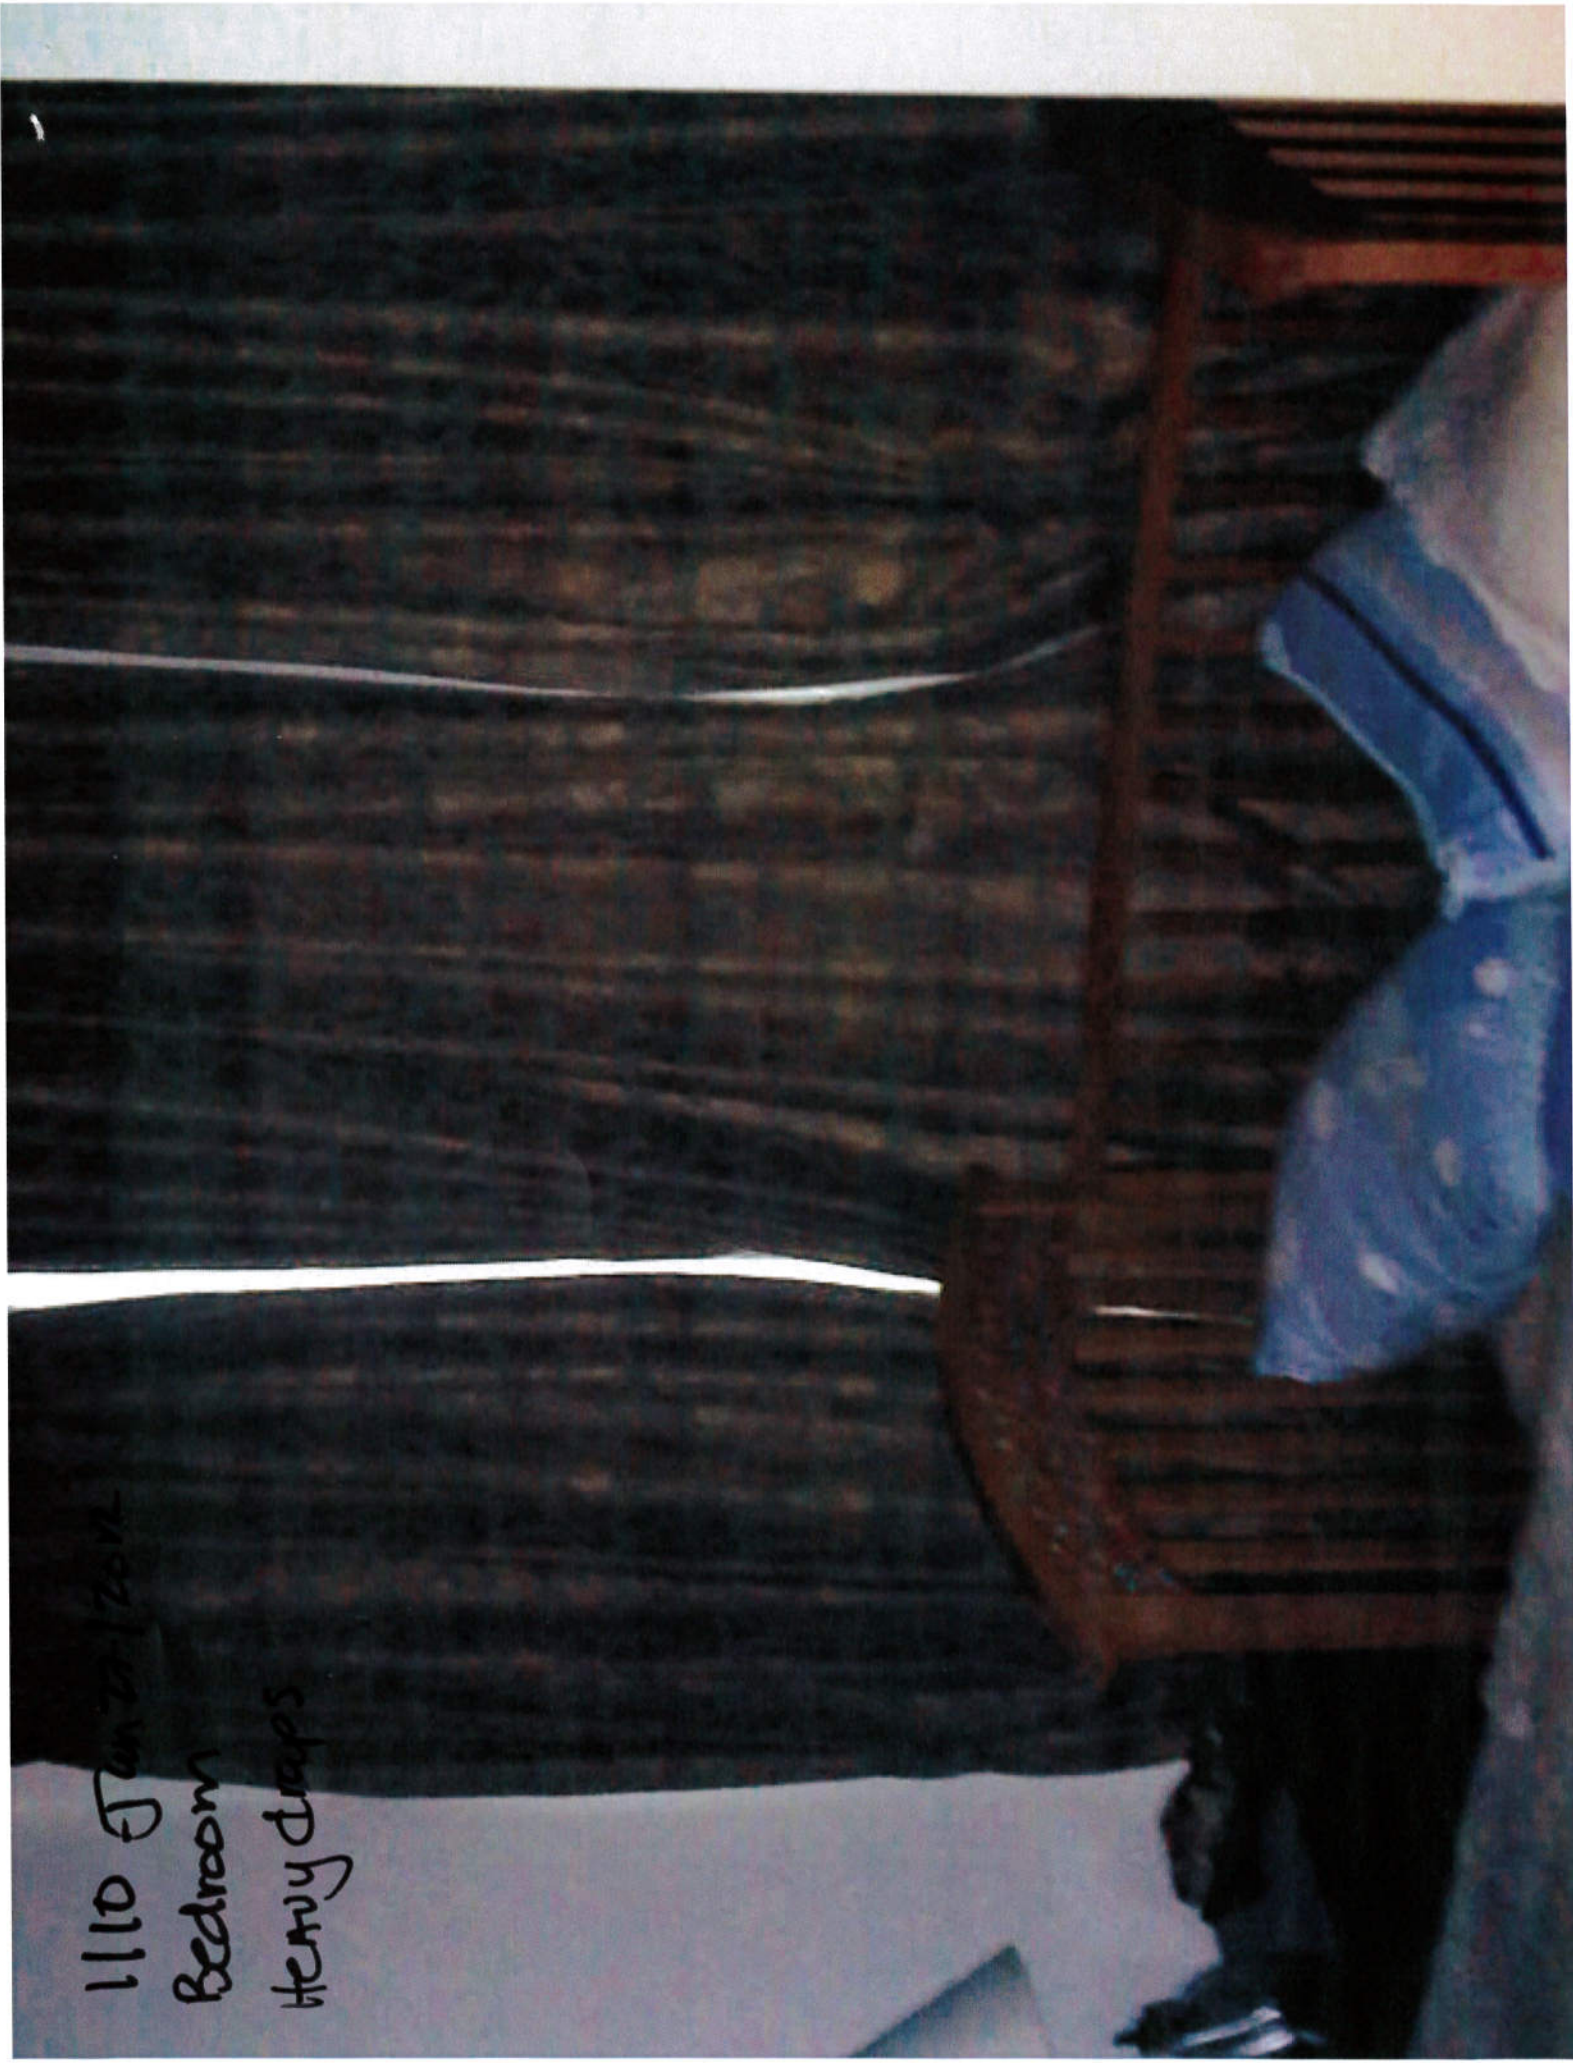
1110 said lots of condensation everything was dry, heavy drapes, furniture against windows see photo's, this is 2nd time to check for same problem

1110 Jan 20/2012
Bedroom
Heavy draps
