## Quality Control-WEB

<b>Vendor / Builder #</b>	43218	<b>Enrollment #</b>	3651234
<b>Purchaser Name:</b>	ROHIT SAHDEV - SUDESH KUMARI	<b>Legal Address:</b>	9 Wayne Allison Drive
<b>Phone Res:</b>	6478623703	<b>Project:</b>	Delpark Homes (Sutton 25) Inc.
<b>Phone Bus:</b>		<b>Plan #:</b>	
<b>Closing Date:</b>	2025-08-01	<b>Lot / Phase #:</b>	20 / E
<b>Inspector:</b>	Samantha French	<b>Municipality:</b>

Inspection Date: Aug 12, 2025

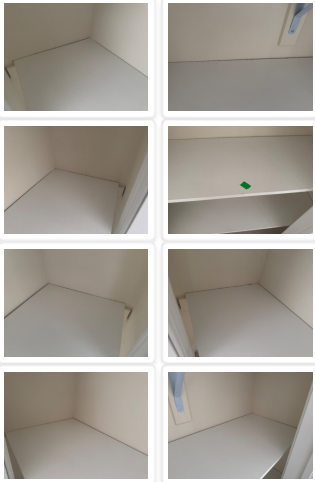
**Deficiency:**  
ALL THE SHELVING INSIDE THE CLOSET IS CHIPPED  
ALONG THE WALL EDGES. ALSO, THE SECOND SHELF  
FROM THE BOTTOM IS CHIPPED AT THE FRONT EDGE.
