**Zancor Homes (Parkview) Ltd.**  
**Warranty Services**  
**Phone: (905) 738-7010**  
**Fax: (905) 738-5948**

**Work Order**

**Location:** Now Towns In Brooklin - Phase: 1 - Lot: Unit 56 (Block 9)

WO Number : **W-084200**WO Date : **20-Oct-2022**Issued To : **ROBERT ULJASZ**Builder : **Zancor****ZAN11**Lot No : **B9-56**Project : **ZANCOR-BROOKLIN TOWNS-3-21**

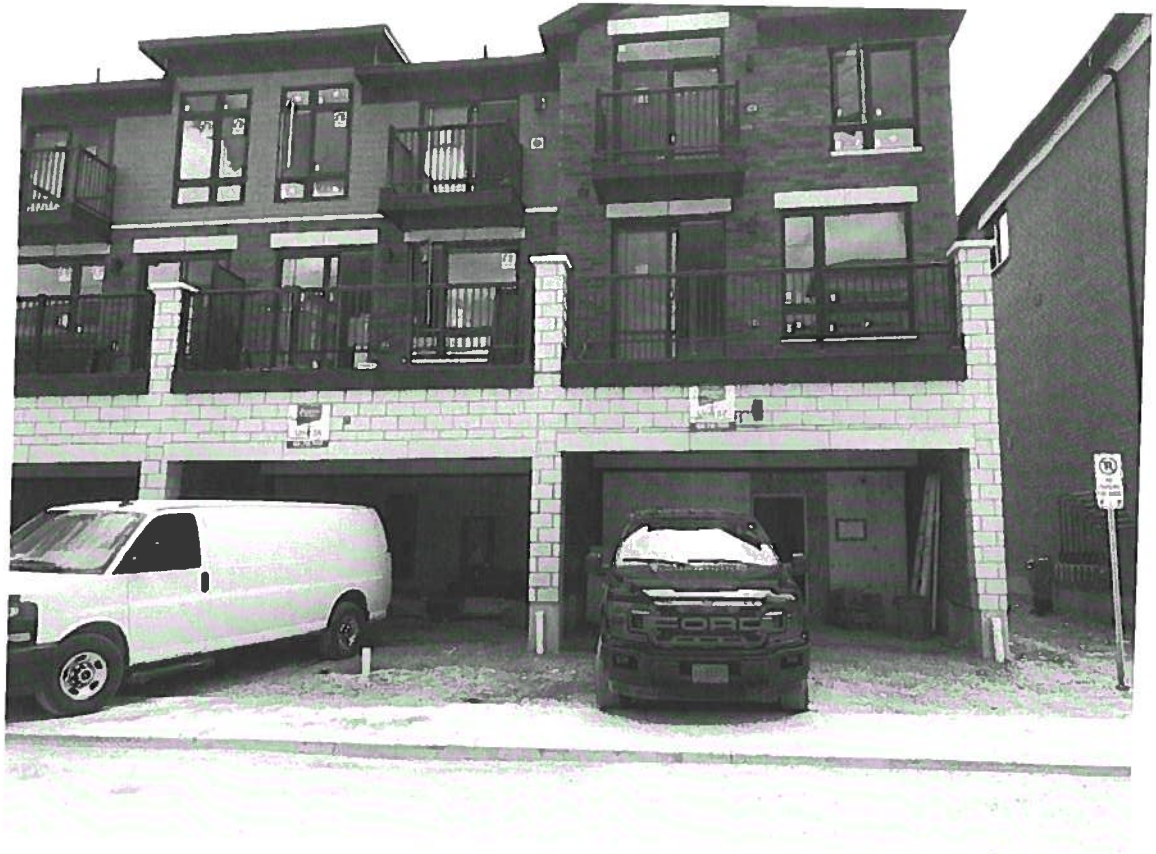
#3

Blk#9 Units#56 & 57 column requires repairing from possibly being struck:
