**MEDI GROUP**

# MEDI GROUP Service

WO Number : W-084201

Project : ZANCOR-BROOKLIN TOWNS-3-21

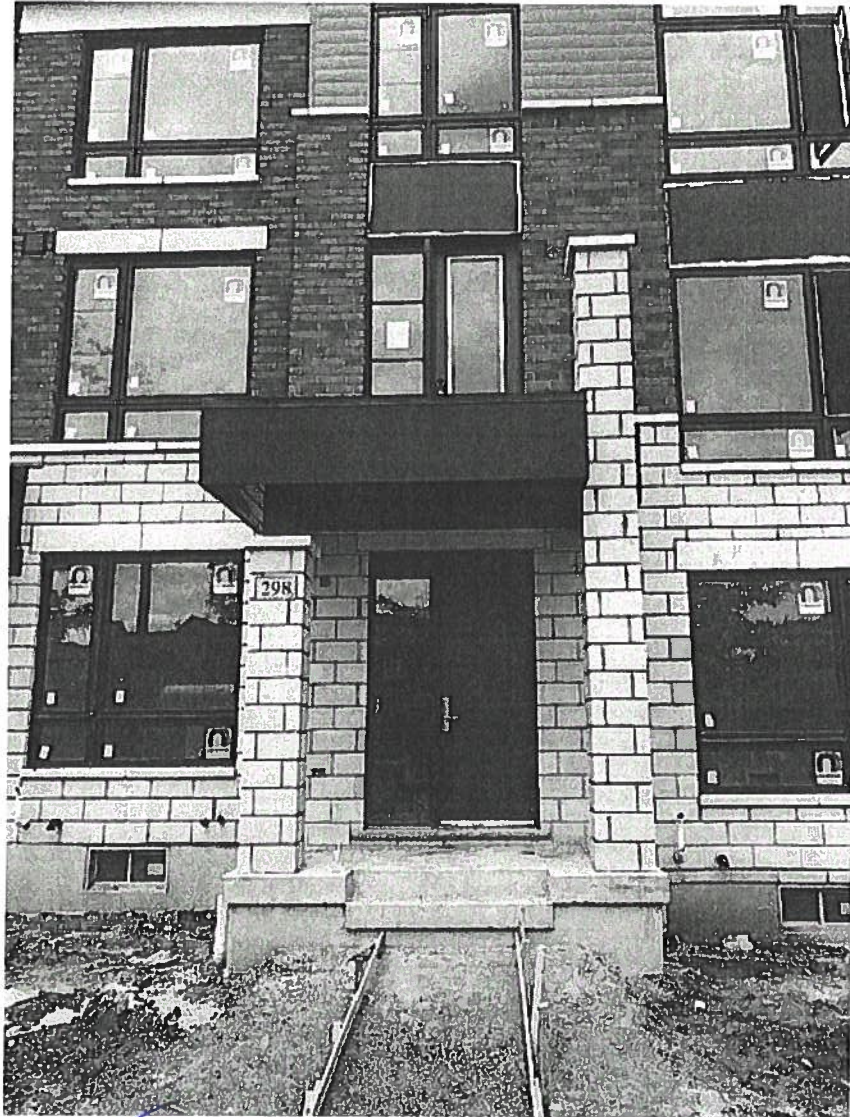
| INIT | Item | Work Description | PO | Builder Ref # |
|---|---|---|---|---|
| <input checked="" type="checkbox"/> | 2 | FRONT COLUMN REMOVE 1 COURSE OF STONE - SEE PHOTO | | S-065541 |

Blk#9 Units#54 & 55 front column remove 1 course of stone:
