MEDI GROUP

WO Number : **W-084202**WO Date : **20-Oct-2022**Issued To : **ROBERT ULJASZ**

Project : ZANCOR-BROOKLIN TOWNS-3-21

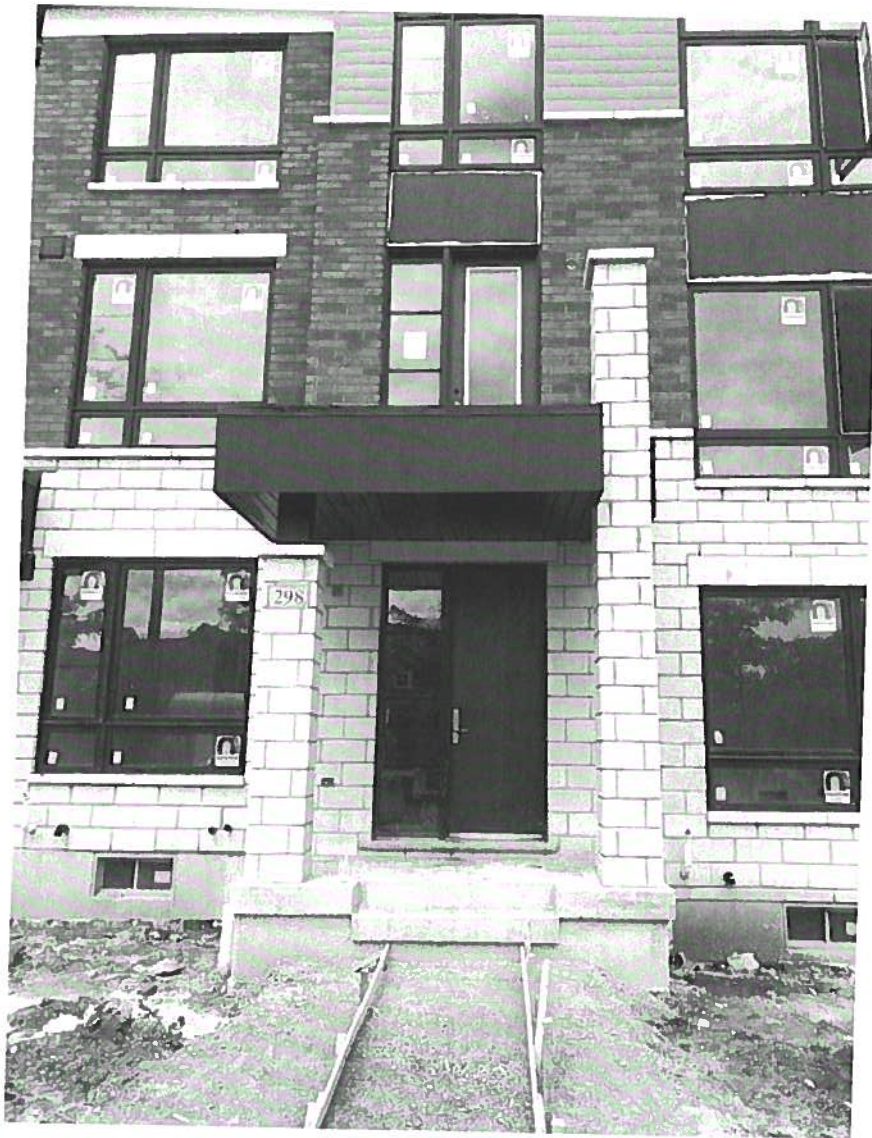
Blk#9 Units#54 & 55 front column remove 1 course of stone:

INIT	Item	Work Description	PO	Builder Ref #
✓	1	ADD MORTAR UNDER STEEL I-BEAM AT R/S (NO INDICATION OF WHERE)		ALLAUG0922
✓	2	FRONT COLUMN REMOVE 1 COURSE OF STONE - SEE PHOTO		S-065541
				08M101541
				S-065545
