Quality Control-WEB

Project: Zancor Homes (Caledon) Ltd.

Lot / Phase #: 96B / 1B

Inspection Date: Nov 07, 2023

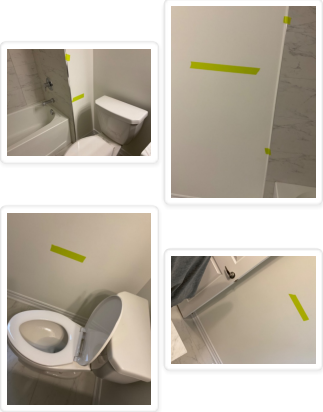
Deficiency:
INSTALL STANDARD BATHROOM ACCESSORIES
THROUGHOUT- SEE PHOTOS
