Zancor Homes (Wasaga River) Ltd.
Warranty Services
Phone: (905) 738-7010
Fax: (905) 738-5948

Work Order

Location: Rivers Edge - Phase: 1 - Lot: 236

Location: Rivers Edge - Phase: 1 - Lot: 355

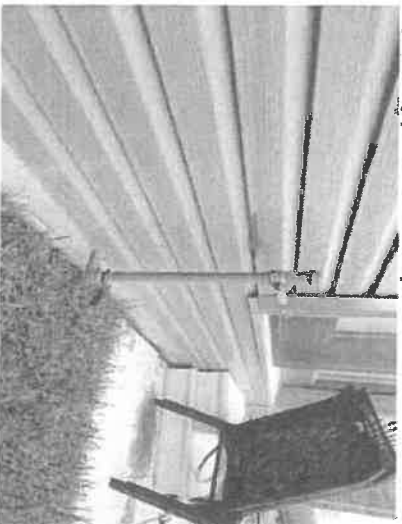
**180130 - 1 -
35303937-5307-4ceb-88cf-98d58623f425 - Gas
Pipes support is inadequate-SVC TO CONFIRM**

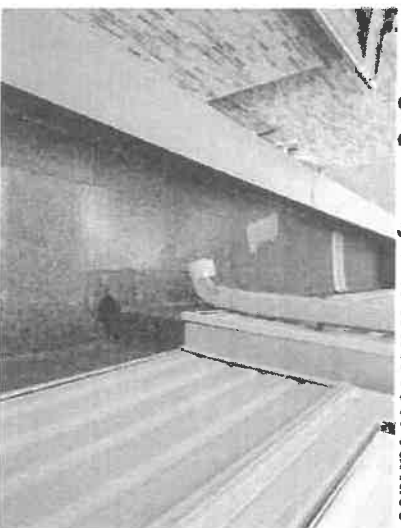
**180131 - 1 -
ff0591aa-8485-4a36-8bac-6e2b3e30a296 - The
downspout for roof drainage system is noted as
discharging directly onto lower roof surface**

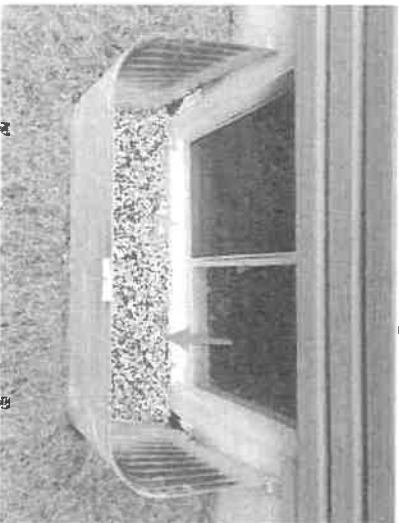
**180140 - 1 - d00d273a-9327-49bf-
aa28-6d664535270c - Windows in the home had
inadequate clearance from grade.- SVC MEASURE**

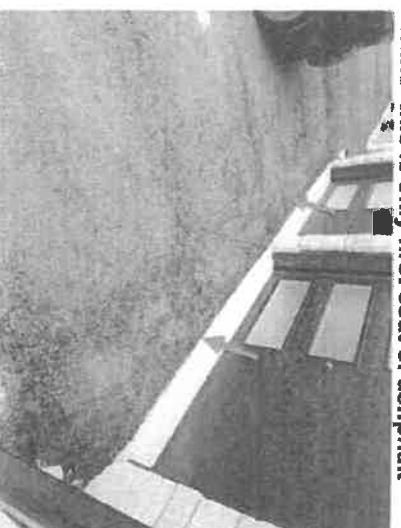
**180145 - 1 -
842f76de-0306-4777-849f-7aba50084410 - A change
in elevation between the referenced surface was
visible- this is only first coat of asphalt**

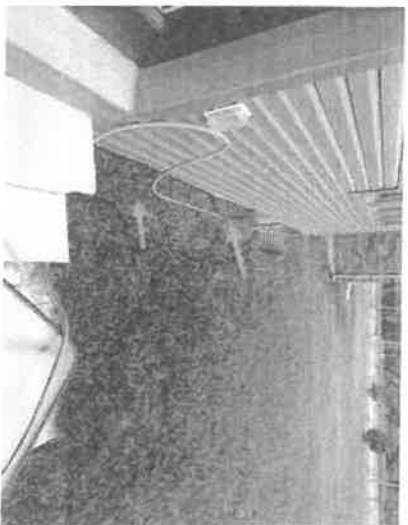
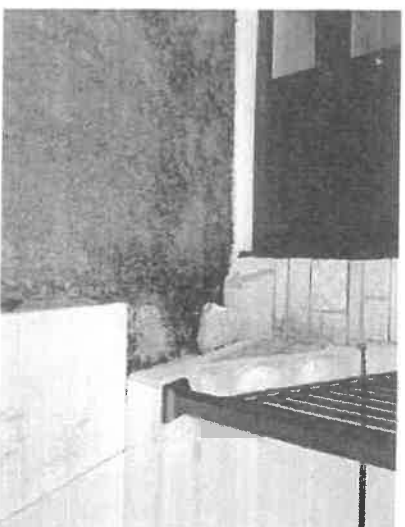
**180146 - 1 - 0b39bc5c-
c93c-41b9-a790-353a662de25c - he buiiding had
areas of neutral or negative drainage that will
route runoff from precipitation toward the
foundation as a result of backfill settlement- SVC
INSPECT AND CONFIRM- REAR AND BY
GARAGE**

**180146 - 2 -
6f0fa156-da6c-47fe-8099-23ddc962115b - he
building had areas of neutral or negative drainage
that will route runoff from precipitation toward the
foundation as a result of backfill settlement- SVC
INSPECT AND CONFIRM- REAR AND BY
GARAGE**

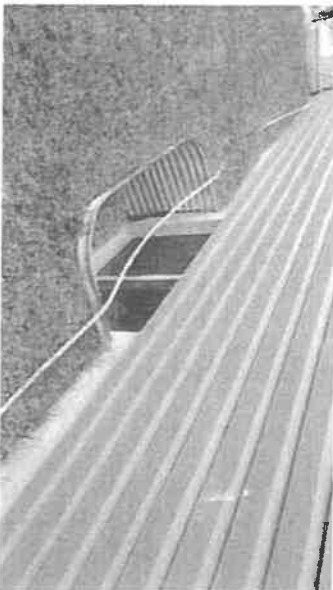
**180147 - 1 -
adeafeb7-2538-4c6a-86c1-fe46a41074dc - One or
more window wells lacked covers at the time of the
inspection-SVC TO MEASURE IF REQUIRED**

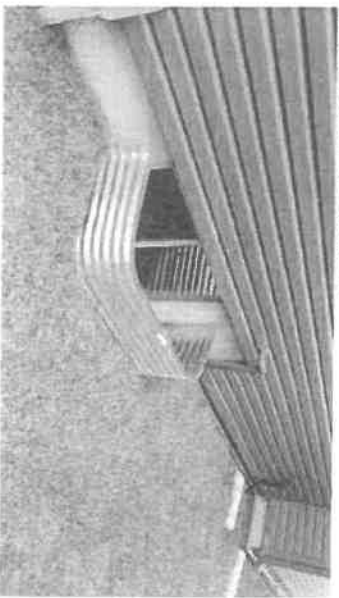
**180147 - 2 - a064dae9-e413-430d-
bc11-c678626c642d - One or more window wells
lacked covers at the time of the inspection-SVC TO
MEASURE IF REQUIRED**

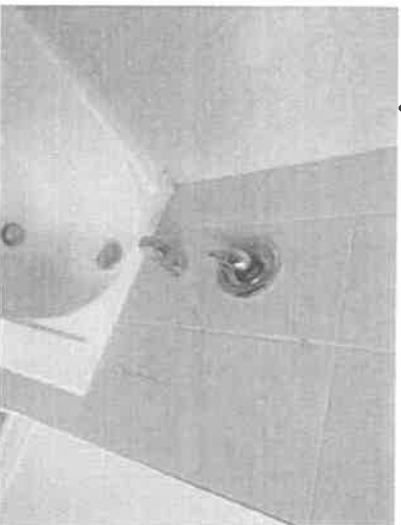
**180151 - 1 -
95638fdd-9c11-4a62-b72b-8d4dfb7b0560 - Sealant
where the bathtub/shower meets the wall had
sections of missing/deteriorated sealant that may
allow damage from moisture intrusion of the wall
assembly.**

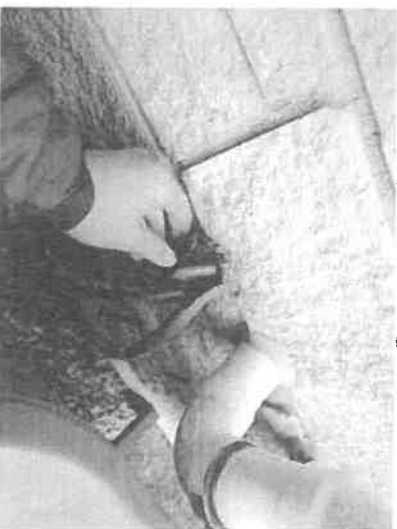
**180153 - 1 - 80000c96-c4e6-4c99-989e-
d45a590d1753 - REFRIGERANT LINES:insulation
on the air-conditioning suction (large, insulated)
line was damaged or missing at areas**

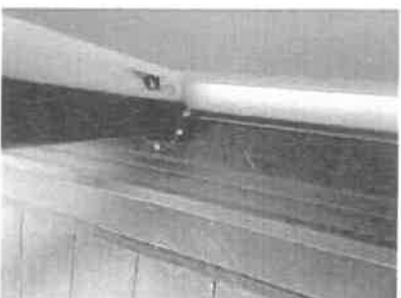
**180113 - 1 - 1212 - Exterior of door has white paint
all over it**

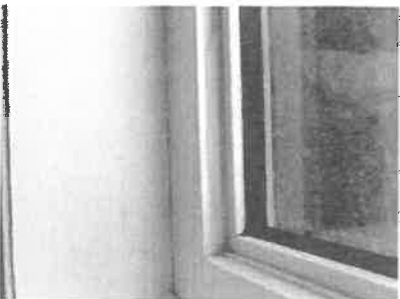
**180116 - 1 - 1212 - Water comes in from bottom of
window which leaks on hardwood floor which has
a few cracks. Rust mark in middle of window on
the inside between glass- PHOTO**
