Customer Care Field Report

Case Reference and Task No.: 11N22A88				2022-03-31	
Completed <input checked="" type="checkbox"/>	Return Visit Required <input type="checkbox"/>	New Issues Reported <input type="checkbox"/>	Reschedule Required <input type="checkbox"/>	Parts Only Required <input type="checkbox"/>	
Technician Name: Abdul Hashimi			Secondary Technician		
Owner Information					
First and Last Name: JUSTIN/ROSE ATTIFIELD			Primary Phone: 6479627830	Secondary Phone:	
Address: 26 Mumberson St			Lot Number: 9	City: Cookstown	
Courtesy Call and Sign In/Out					
Time of Sign In at Trailer/Arrival at Site:		Time of Sign Out at Trailer/Departure from Site:			
Time of Courtesy Call:					
Work Performed					
Deficiency Number	Wdw Fail Code	Door Fail Code	Description	Photos Yes / No	
1	DOPP		*** The bedroom-2 csmnt operator Roto gear has been replaced. Also the top and bottom hinges have been adjusted.	<input type="checkbox"/>	<input type="checkbox"/>

Service Case Autopsy Report Glass Stress Cracks

Install report

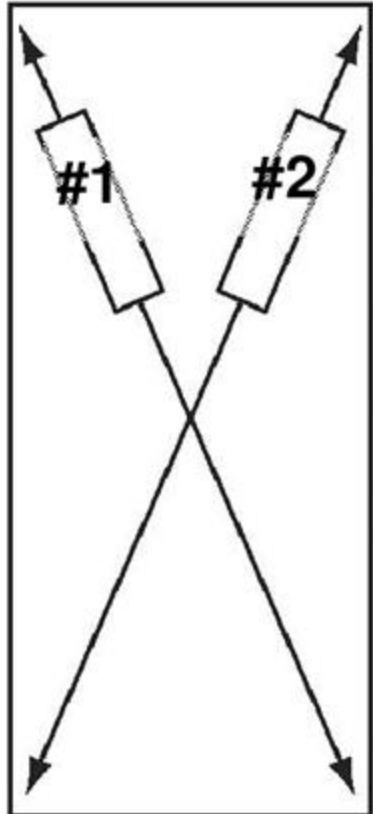
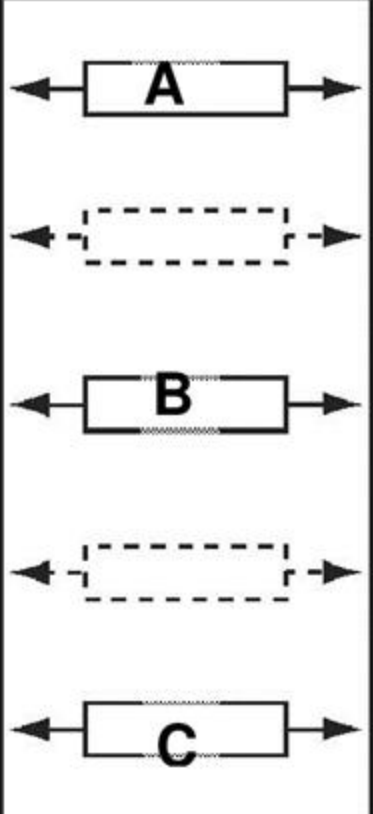
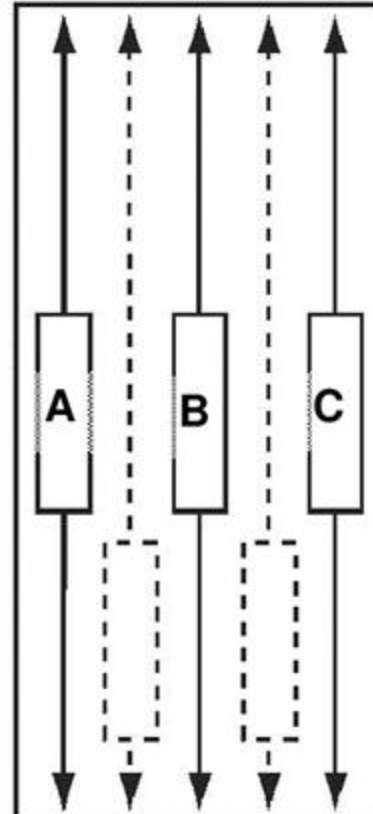
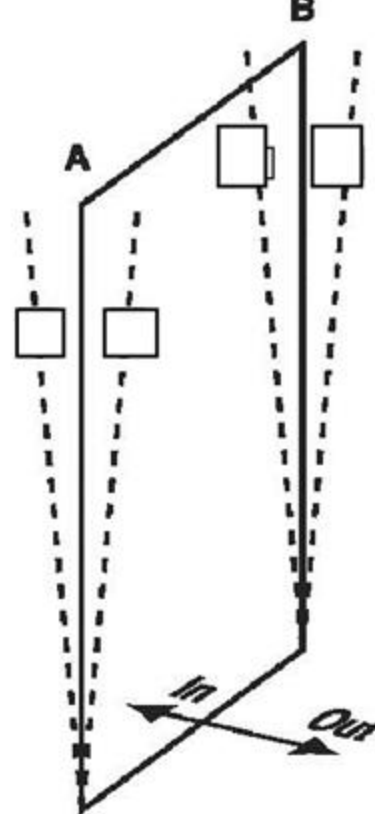
<p>Mesure de coin à coin (équerre) Corner to corner measurement (squareness)</p>	<p>Mesure horizontale (largeur) Horizontal measurements (width)</p>	<p>Mesure verticale (hauteur) Vertical measurements (height)</p>	<p>Aplomb Plumbness</p>

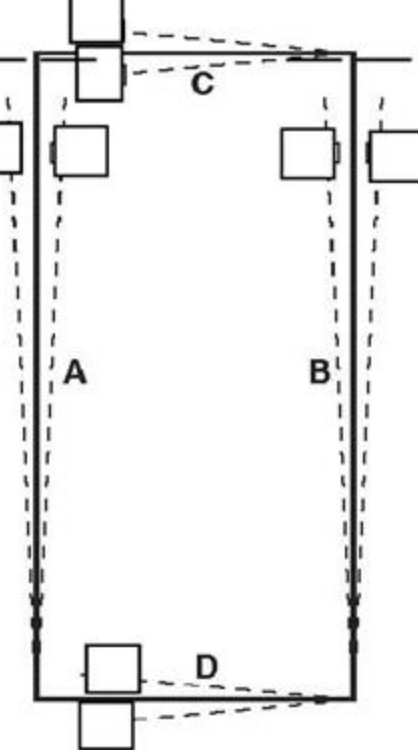
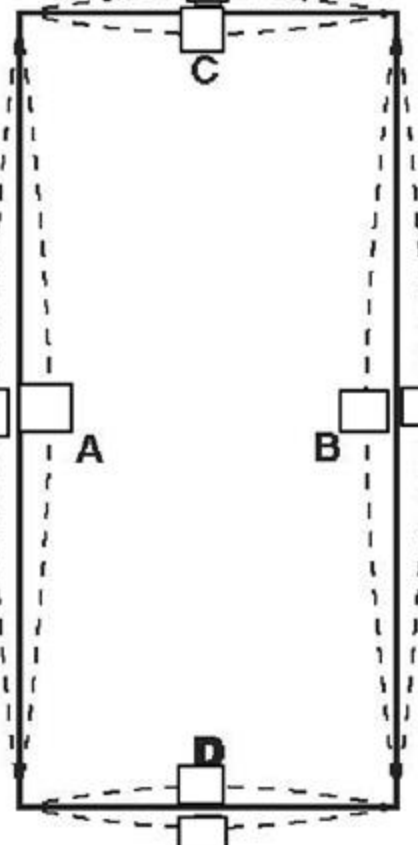
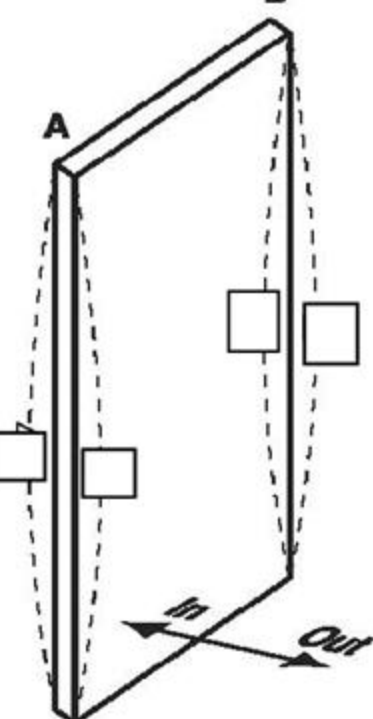
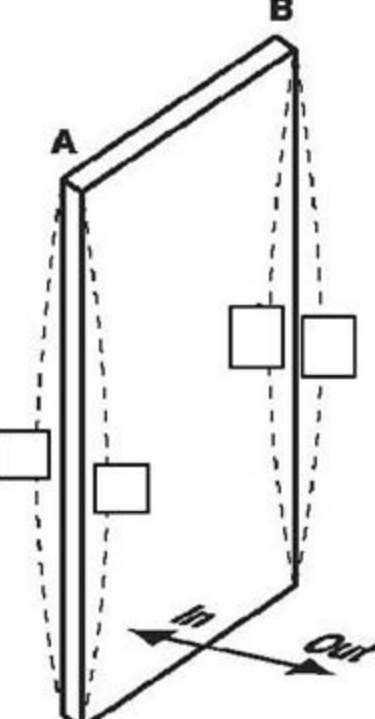
<p>Niveau (2 jambages, tête, seuil) cocher les boîtes selon le côté (inscrire mesure) level (2 jambs, head, sill); check boxes as needed (write down measurements)</p>	<p>Courbes des jambages (de côté) cocher les boîtes selon le côté (inscrire mesure) Bowed jambs (sideway); check boxes as needed (write down measurements)</p>	<p>Courbes des jambages Bowed jambs</p>	<p>Courbes des jambages Bowed jambs</p>
